# Campbells Bay Monitoring Report 2025

Campbells Bay is monitored by Auckland Council’s Coastal Processes Monitoring Programme to determine rates of sand gain (accretion), or sand loss (erosion), identify storm impacts, and monitor beach operations. By improving our understanding of how Auckland’s coastline changes over time, we can make more informed decisions to manage coastal hazards, guide beach maintenance, and support the resilience of our beaches into the future.

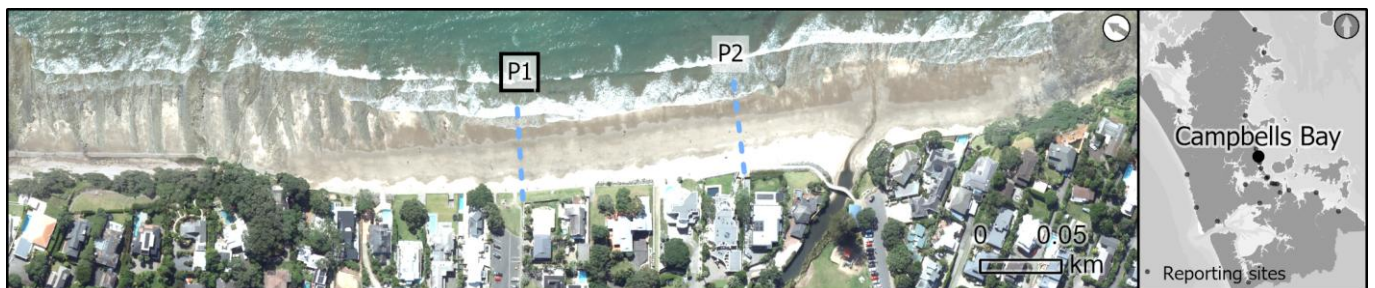
**Figure 1:** Location of the 2 monitored beach profiles at Campbells Bay. The representative profile shown in Figure 2 is highlighted with a black border. All beaches included in this reporting scheme are shown on the right-hand side map of Auckland.

The Coastal Processes Programme monitors sand levels at Campbells Bay with 2 profile lines running perpendicular to the shoreline (Figure 1). These long-term records help us track changes in beach width and beach volume over time.

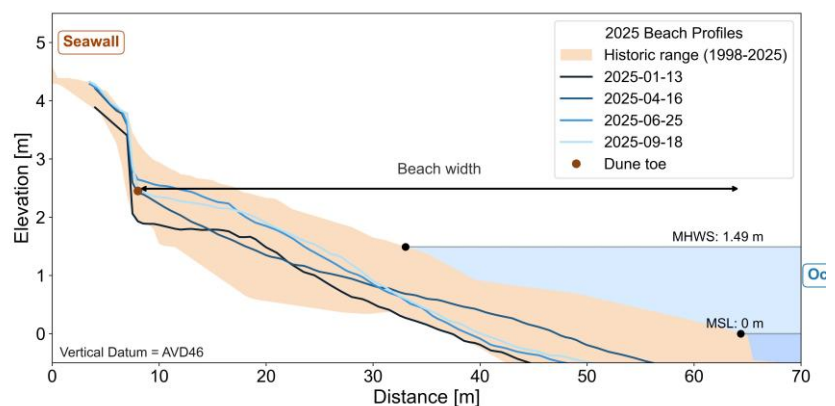
Figure 2 shows historic sand levels at Campbells Bay Profile 1, from the seawall down to the water level.

In 2025, sand levels across the beach fluctuated within the lower half of the historic range (Figure 2). In January, levels dropped to the bottom of the range at the upper beach but increased through the year. At the lower beach, sand levels rose in April before declining again, leading to a steepening beach profile.

**Figure 2:** Changes in sand levels at Campbells Bay P1. Mean Sea Level (MSL) represents the average mid-tide level, Mean High Water Springs (MHWS) marks the average high-tide line. Beach width is the distance between seawall toe and MSL.

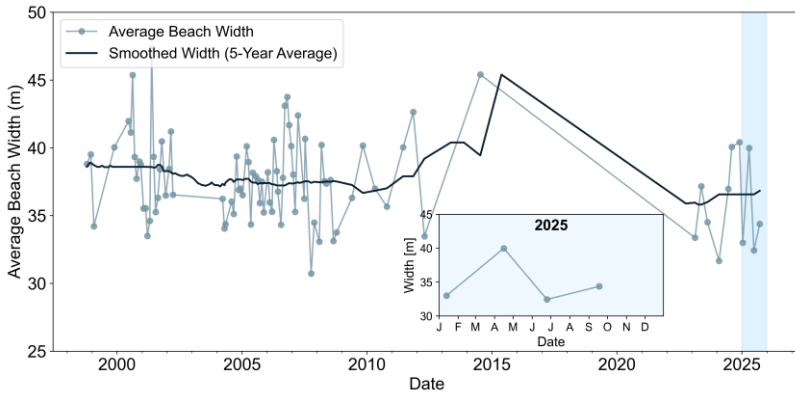
**Figure 3:** Beach-wide averaged width (calculated between seawall toe and MSL) at Campbells Bay.

Campbells Bay shows long-term erosion, with a slight reduction in average beach width over time and notable short-term fluctuations driven by locally to regionally generated storm waves (Figure 3).  
In 2025, average beach width increased by around 7 m between January and April, then decreased by a similar amount by July, followed by a slight recovery by October.

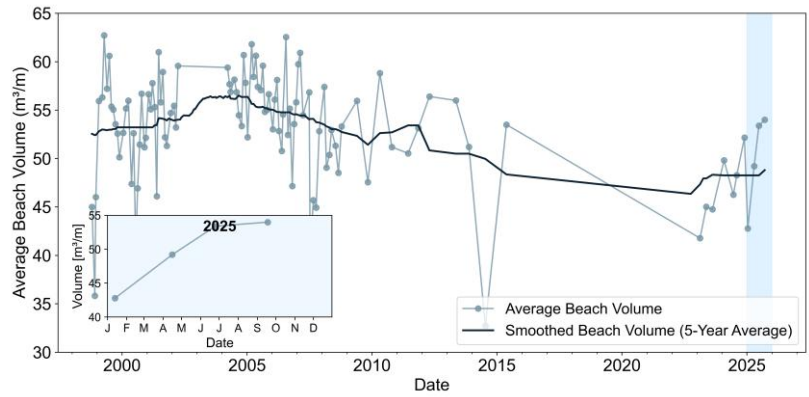
Since consistent monitoring began in the 1990s, the amount of sand at Campbells Bay has reduced (Figure 4).  
However, this year average beach volume at Campbells Bay has increased considerably since January with sediment deposition concentrated at the upper beach (Figure 2). As a result, changes in beach width at MSL shown in Figure 3 do not reflect this (Figure 4).

**Figure 4:** Beach-wide averaged volume (calculated above MSL) at Campbells Bay.
