# Cheltenham Beach Monitoring Report 2025

Cheltenham Beach is monitored by Auckland Council’s Coastal Processes Monitoring Programme to determine rates of sand gain (accretion), or sand loss (erosion), identify storm impacts, and monitor beach operations. By improving our understanding of how Auckland’s coastline changes over time, we can make more informed decisions to manage coastal hazards, guide beach maintenance, and support the resilience of our beaches into the future.

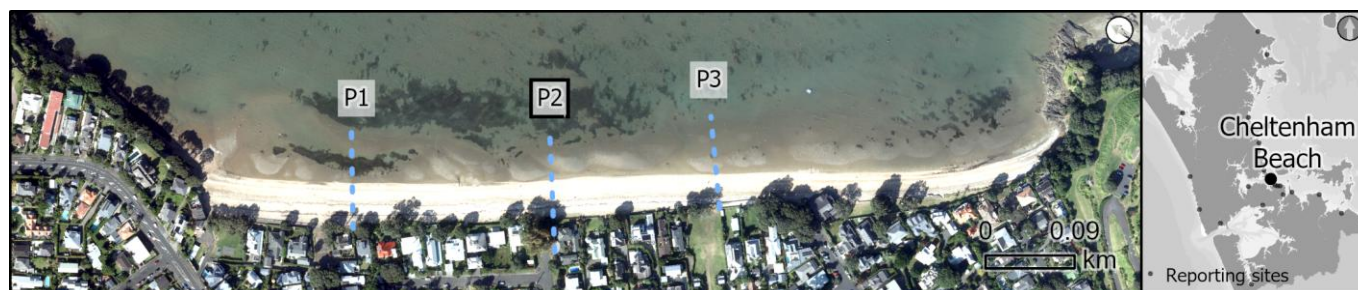
**Figure 1:** Location of the 3 monitored beach profiles at Cheltenham Beach. The representative profile shown in Figure 2 is highlighted with a black border. All beaches included in this reporting scheme are shown on the right-hand side map of Auckland.

The Coastal Processes Programme monitors sand levels at Cheltenham Beach with 3 profile lines running perpendicular to the shoreline (Figure 1). These long-term records help us track changes in beach width and beach volume over time.

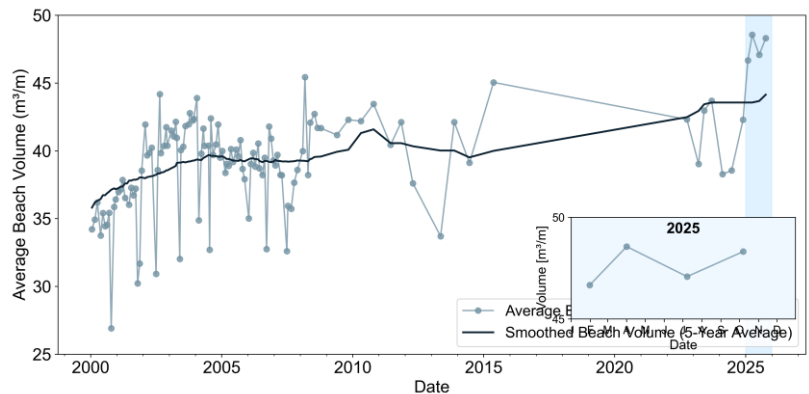
**Figure 4:** Beach-wide averaged volume (calculated above MSL) at Cheltenham Beach.

Since consistent monitoring began in the 1990s, the amount of sand at Cheltenham Beach has increased but shows large fluctuations in beach volume throughout the monitoring record (Figure 4).

In 2025, average beach volume at Cheltenham Beach shows only small fluctuations where loss of sand at the northern end of the beach in July and October is balanced by sand gains at the southern end of the beach.
