Long Bay Monitoring Report 2025

Long Bay is monitored by Auckland Council’s Coastal Processes Monitoring Programme to determine rates of sand gain (accretion), or sand loss (erosion), identify storm impacts, and monitor beach operations. By improving our understanding of how Auckland’s coastline changes over time, we can make more informed decisions to manage coastal hazards, guide beach maintenance, and support the resilience of our beaches into the future.

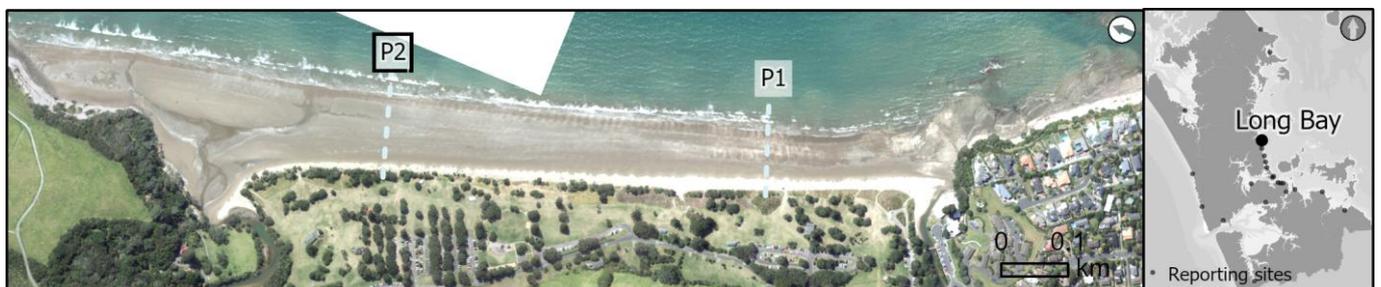
The Coastal Processes Programme monitors sand levels at Long Bay with 2 profile lines running perpendicular to the shoreline (Figure 1). These long-term records help us track changes in beach width and beach volume over time.

Figure 1: Location of the 2 monitored beach profiles at Long Bay. The representative profile shown in Figure 2 is highlighted with a black border. All beaches included in this reporting scheme are shown on the right-hand side map of Auckland.

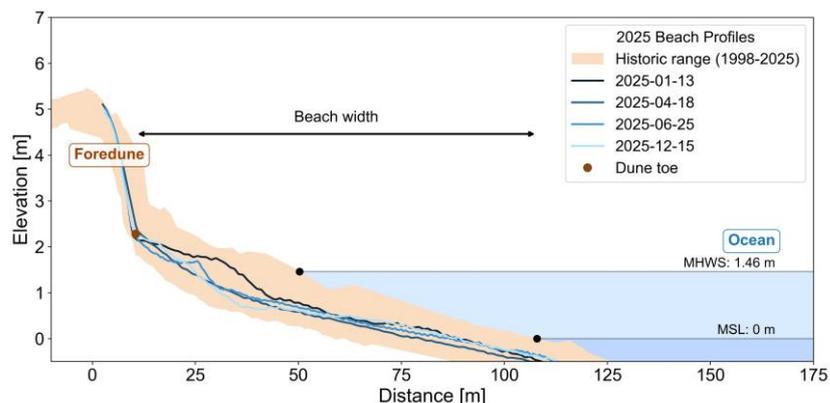
Figure 2 shows historic sand levels at Long Bay Profile 2, from the dunes down to the water level. Sand levels are currently sitting in the lower half of the historic range indicating sand levels are relatively low especially around the MHWS line but have been lower in the past (Figure 2).

Throughout 2025, sand levels have been relatively stable below MHWS, however the upper beach has experienced considerable beach lowering between January and December (Figure 2).

Figure 2: Changes in sand levels at Long Bay P2. Mean Sea Level (MSL) represents the average mid-tide level, Mean High Water Springs (MHWS) marks the average high-tide line. Beach width is the distance between dune toe and MSL.

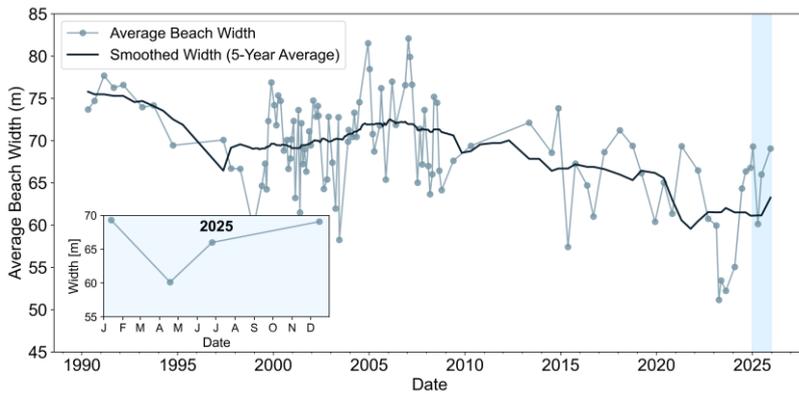
Figure 3: Beach-wide averaged width (calculated between dune toe and MSL) at Long Bay.

Long Bay exhibits long-term narrowing (erosion) but with considerable short-term fluctuations likely due to storms and large swell events (Figure 3). For example, nearly 10 m of beach narrowing in response to Cyclone Gabrielle in 2023 is clearly visible in the record. In 2025, beach width decreased from ~70 m in January to ~60 m in April, before recovering back to ~65 in July and ~70 m in December.

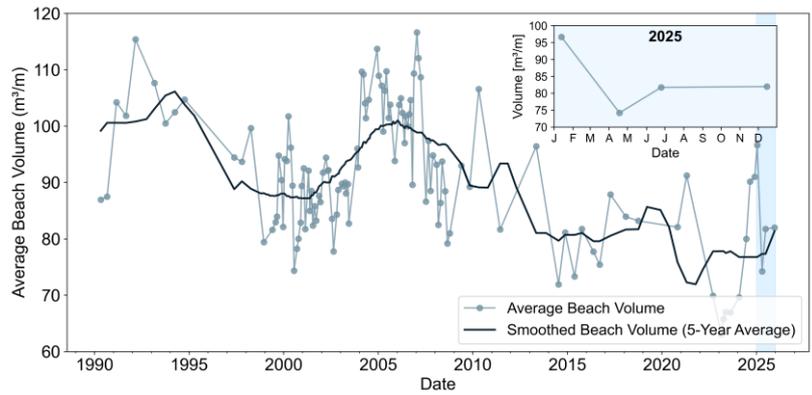
Since monitoring began in the 1990s, Long Bay has shown a long-term reduction in beach volume, alongside decadal-scale cycles and short-term fluctuations, likely driven by changes in wave climate and storm events, that temporarily move sand offshore (Figure 4). In 2025, beach volume was highest in January due to sand deposition near MHWS, followed by a sharp decline in April and slow recovery towards the end of the year.

Figure 4: Beach-wide averaged volume (calculated above MSL) at Long Bay.
