Milford Beach Monitoring Report 2025

Milford Beach is monitored by Auckland Council’s Coastal Processes Monitoring Programme to determine rates of sand gain (accretion), or sand loss (erosion), identify storm impacts, and monitor beach operations. By improving our understanding of how Auckland’s coastline changes over time, we can make more informed decisions to manage coastal hazards, guide beach maintenance, and support the resilience of our beaches into the future.

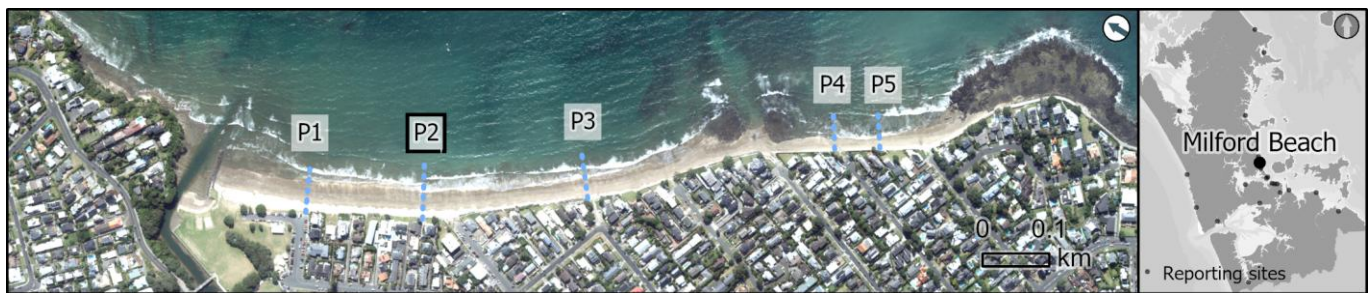
The Coastal Processes Programme monitors sand levels at Milford Beach with 5 profile lines running perpendicular to the shoreline (Figure 1). These long-term records help us track changes in beach width and beach volume over time.

Figure 1: Location of the 5 monitored beach profiles at Milford Beach. The representative profile shown in Figure 2 is highlighted with a black border. All beaches included in this reporting scheme are shown on the right-hand side map of Auckland.

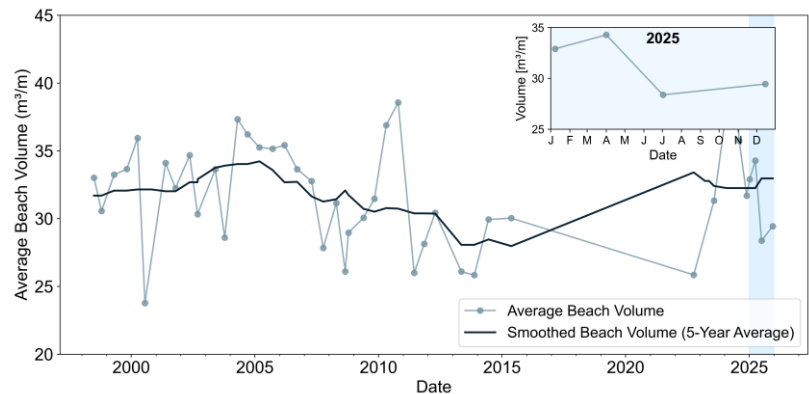
Since consistent monitoring began in the 1990s, the amount of sand at Milford Beach has fluctuated considerably but over the long-term beach volume has remained relatively stable (Figure 4).

In 2025, average beach volume decreased considerably over winter before experiencing a small recovery by December. The July decline in average beach volume is largely driven by sand loss from the northern part of the beach during winter.

Figure 4: Beach-wide averaged volume (calculated above MSL) at Milford Beach.
