# Orewa Beach Monitoring Report 2025

Orewa Beach is monitored by Auckland Council’s Coastal Processes Monitoring Programme to determine rates of sand gain (accretion), or sand loss (erosion), identify storm impacts, and monitor beach operations. By improving our understanding of how Auckland’s coastline changes over time, we can make more informed decisions to manage coastal hazards, guide beach maintenance, and support the resilience of our beaches into the future.

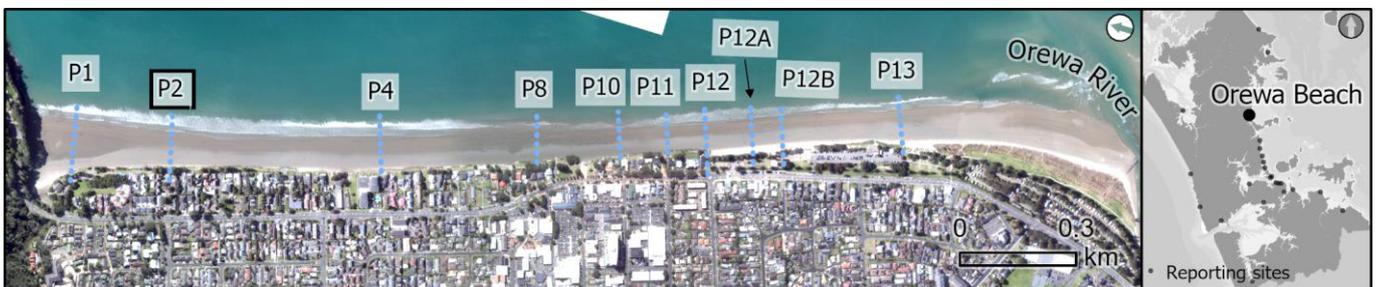
The Coastal Processes Programme monitors sand levels at Orewa Beach with 10 profile lines running perpendicular to the shoreline (Figure 1). These long-term records help us track changes in beach width and beach volume over time.

**Figure 1:** Location of the 10 monitored beach profiles at Orewa Beach. The representative profile shown in Figure 2 is highlighted with a black border. All beaches included in this reporting scheme are shown on the right-hand side map of Auckland.

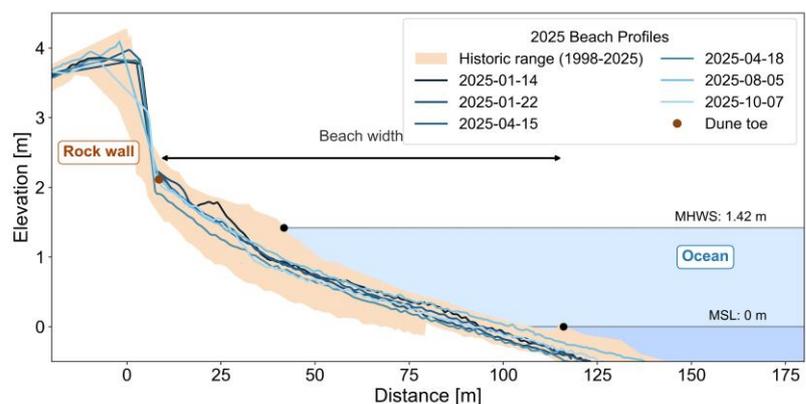
Figure 2 shows historic sand levels at Orewa Beach Profile 2, from the rock revetment down to the water level. Sand levels at Orewa Beach are currently in the middle of the historic range indicating a moderate beach state relative to past conditions (Figure 2).

In 2025, sand levels dropped after high-energy events at the start of the year, reaching their lowest after Cyclone Tam (April). Since then, the upper beach has partly recovered, but sand levels below MHWS remain low.

**Figure 2:** Changes in sand levels at Orewa Beach P2. Mean Sea Level (MSL) represents the average mid-tide level, Mean High Water Springs (MHWS) marks the average high-tide line. Beach width is the distance between dune toe and MSL.

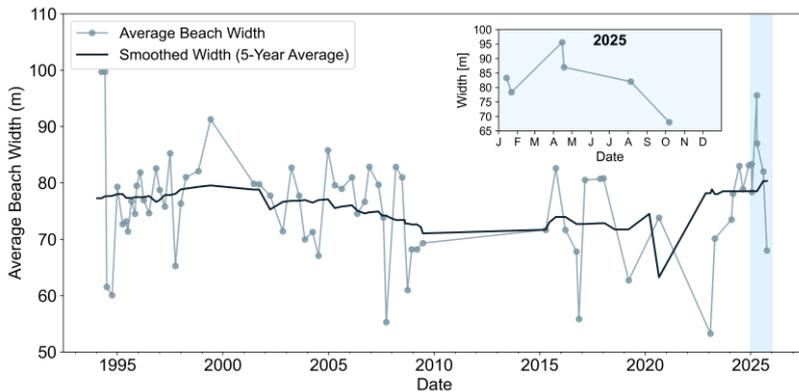
**Figure 3:** Beach-wide averaged width (calculated between dune toe and MSL) at Orewa Beach.

Figure 3 indicates that beach width at Orewa Beach exhibits long-term stability but with considerable short-term fluctuations likely due to storms and large swell events temporarily moving sediment offshore. For example, beach width reduced by ~15 m after Cyclone Gabrielle in 2023.

In 2025, beach width decreased after a January storm before recovering as sand returned to the beach. It dropped again after Cyclone Tam and continued to reduce over the rest of the year (Figure 3).

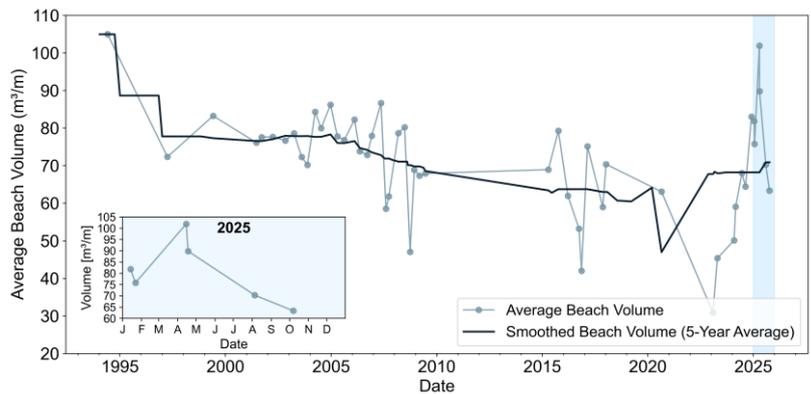
Since consistent monitoring began in the 1990s, the amount of sand at Orewa Beach has remained relatively stable but with large fluctuations observed throughout the record (Figure 4).

Similar to changes in beach width, beach volume dropped following Cyclone Tam in April, and has continued to decrease throughout the year, likely due to winter wave conditions keeping sediment offshore.

**Figure 4:** Beach-wide averaged volume (calculated above MSL) at Orewa Beach.

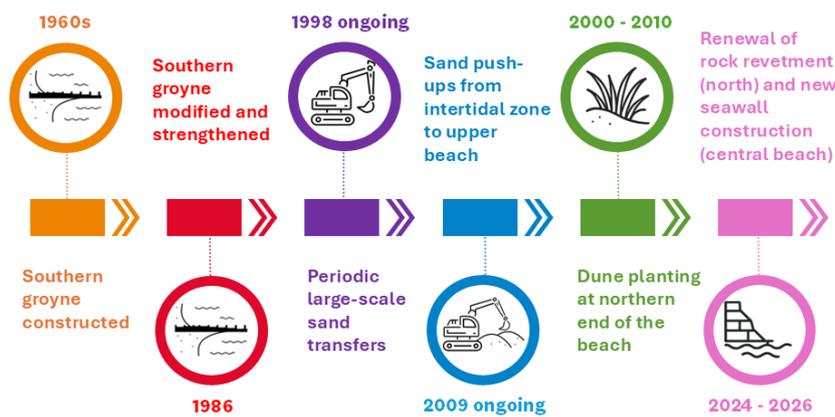
Orewa Beach is a relatively modified beach with a number of engineered structures and ongoing operations to maintain the position of the shoreline and help keep sand on the beach. A new seawall along the central to northern beach is due to be completed early 2026.

Large-scale sand transfers (last undertaken in 2023), and sand pushups, are also periodically undertaken to redistribute sediment on the beach.
