# Piha Beach Monitoring Report 2025

Piha Beach is monitored by Auckland Council’s Coastal Processes Monitoring Programme to determine rates of sand gain (accretion), or sand loss (erosion), identify storm impacts, and monitor beach operations. By improving our understanding of how Auckland’s coastline changes over time, we can make more informed decisions to manage coastal hazards, guide beach maintenance, and support the resilience of our beaches into the future.

This report presents changes at Piha Beach over the last year. Check out the latest [State of Environment report](#) to explore long-term trends of beach change in Tāmaki Makaurau or [click here](#) to learn more about how we measure and describe changes at the coast.

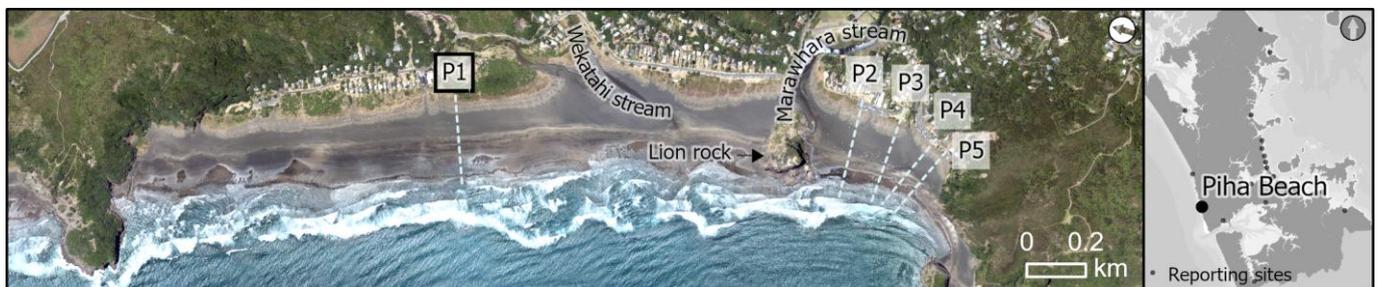
**Figure 1:** Location of the 5 monitored beach profiles at Piha Beach. The representative profile shown in Figure 2 is highlighted with a black border. All beaches included in this reporting scheme are shown on the right-hand side map of Auckland.

The Coastal Processes Programme monitors sand levels at Piha Beach with 5 profile lines running perpendicular to the shoreline (Figure 1). These long-term records help us track changes in beach width and beach volume over time.

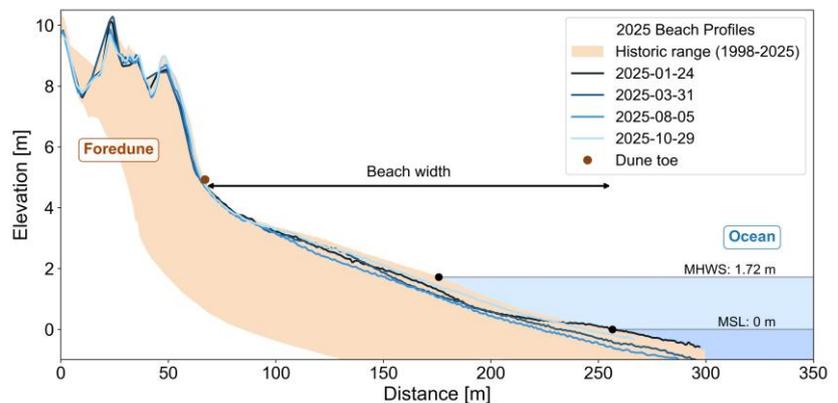
Figure 2 shows historic sand levels at Piha Beach Profile 1, from the dunes down to the water level. Sand levels at Piha Beach are currently extremely high with the four 2025 beach surveys positioned at the top of the historic range (Figure 2).

In 2025, sand levels have not changed considerably. Beach lowering can be seen in August, but by December sand levels are again at the top of the historic range indicating that Piha Beach is experiencing the highest sand levels on record.

**Figure 2:** Changes in sand levels at Piha Beach P1. Mean Sea Level (MSL) represents the average mid-tide level, Mean High Water Springs (MHWs) marks the average high-tide line. Beach width is the distance between dune toe and MSL.

For example, beach width increased from ~140 m in January to nearly 150 m in April, before narrowing to ~125 m in October this year. Sand levels remain high at North Piha (Profile 1; Figure 2), but recent losses at South Piha (Profiles 2–5) have reduced the average width to below 125 m.

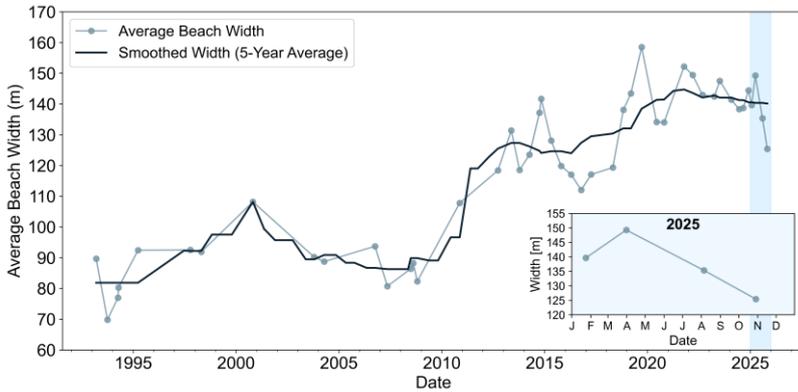
**Figure 3:** Beach-wide averaged width (calculated between dune toe and MSL) at Piha Beach.

Piha Beach exhibits long-term widening (accretion) but with considerable short-term fluctuations likely due to storms and large swell events (Figure 3).

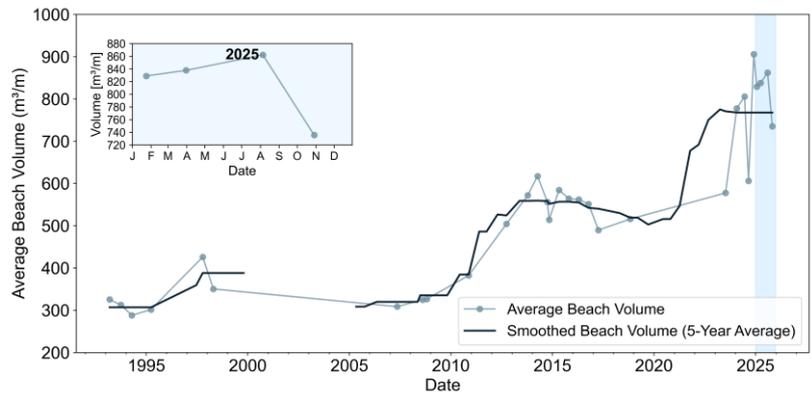
Since consistent monitoring began in the 1990s, the amount of sand at Piha Beach has roughly doubled (Figure 4). Despite the long-term trend of sand gain, large drops in beach volume can be observed throughout the record likely in response to storm events temporarily transporting sediment off the beach.

This year, recent erosion at South Piha significantly reduced the average beach volume measured in late October (Figure 4).

**Figure 4:** Beach-wide averaged volume (calculated above MSL) at Piha Beach.
