Takapuna Beach Monitoring Report 2025

Takapuna Beach is monitored by Auckland Council’s Coastal Processes Monitoring Programme to determine rates of sand gain (accretion), or sand loss (erosion), identify storm impacts, and monitor beach operations. By improving our understanding of how Auckland’s coastline changes over time, we can make more informed decisions to manage coastal hazards, guide beach maintenance, and support the resilience of our beaches into the future.

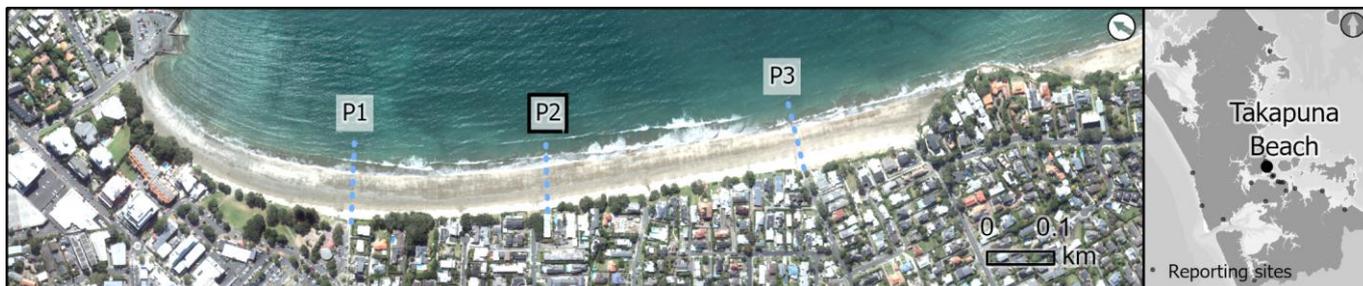
The Coastal Processes Programme monitors sand levels at Takapuna Beach with 3 profile lines running perpendicular to the shoreline (Figure 1). These long-term records help us track changes in beach width and beach volume over time.

Figure 1: Location of the 3 monitored beach profiles at Takapuna Beach. The representative profile shown in Figure 2 is highlighted with a black border. All beaches included in this reporting scheme are shown on the right-hand side map of Auckland.

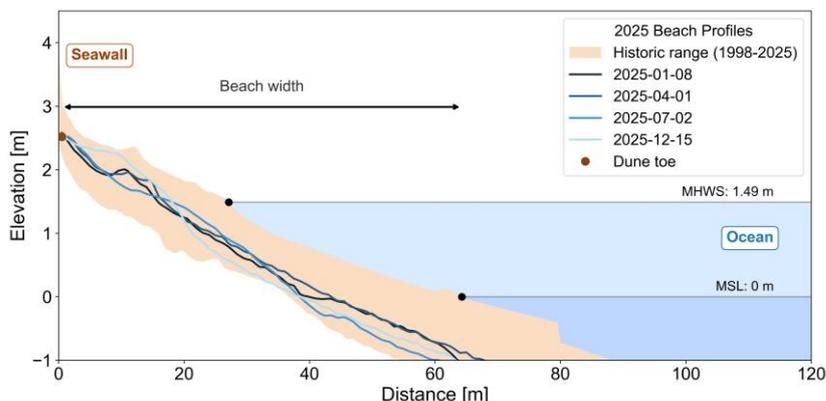
Figure 2 shows historic sand levels at Takapuna Beach Profile 2, from the seawall down to the water level. Sand levels currently vary across the beach, with sand levels near the top of the historic range at the upper beach, and lower levels closer to the water resulting in a steepening beach profile (Figure 2).

In late 2025, sand appears to have shifted from the lower to the upper beach, lowering levels below MHWS and building up sand near the top of the beach.

Figure 2: Changes in sand levels at Takapuna Beach P2. Mean Sea Level (MSL) represents the average mid-tide level, Mean High Water Springs (MHWS) marks the average high-tide line. Beach width is the distance between dune toe and MSL.

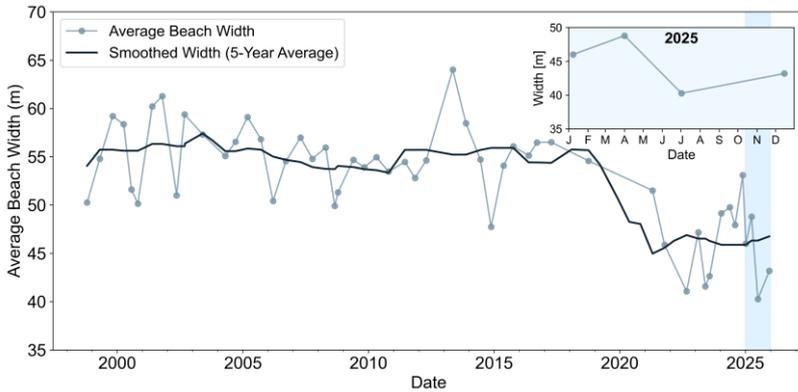
Figure 3: Beach-wide averaged width (calculated between dune toe and MSL) at Takapuna Beach.

Takapuna Beach exhibited relative stability in beach width for the first 20 years of the monitoring record. After 2020, recent narrowing (erosion) reduced average beach width by ~10 m, however considerable short-term fluctuations can also be observed throughout the record.

In 2025, beach width increased to ~50 m in April before reducing to ~40 m in July, likely driven by seasonal changes in wave conditions (Figure 3).

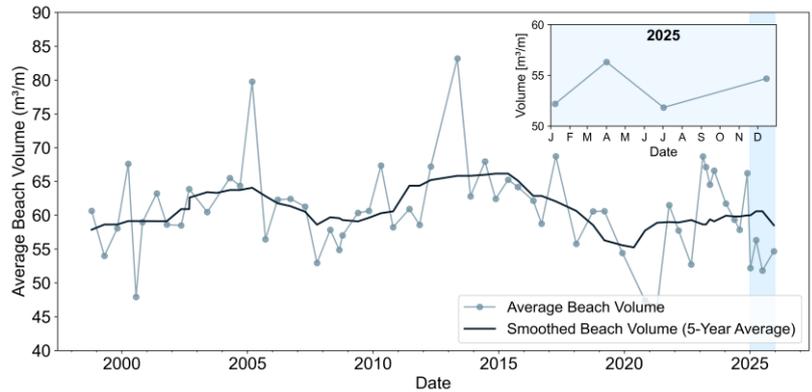
Since consistent monitoring began in the 1990s, the amount of sand at Takapuna Beach has remained relatively stable (Figure 4). However, large fluctuations in beach volume can be observed throughout the record likely in response to decadal and seasonal changes in wave climate, as well as storms temporarily transporting sediment off the beach.

This year, beach volume at Takapuna Beach was at it's highest in April, followed by a drop in July, before recovering towards the end of the year (Figure 4).

Figure 4: Beach-wide averaged volume (calculated above MSL) at Takapuna Beach.
